TOWARDS IMPROVED FIRE MANAGEMENT IN LANDFILL SITES

A review by I.R.S Services July 2012

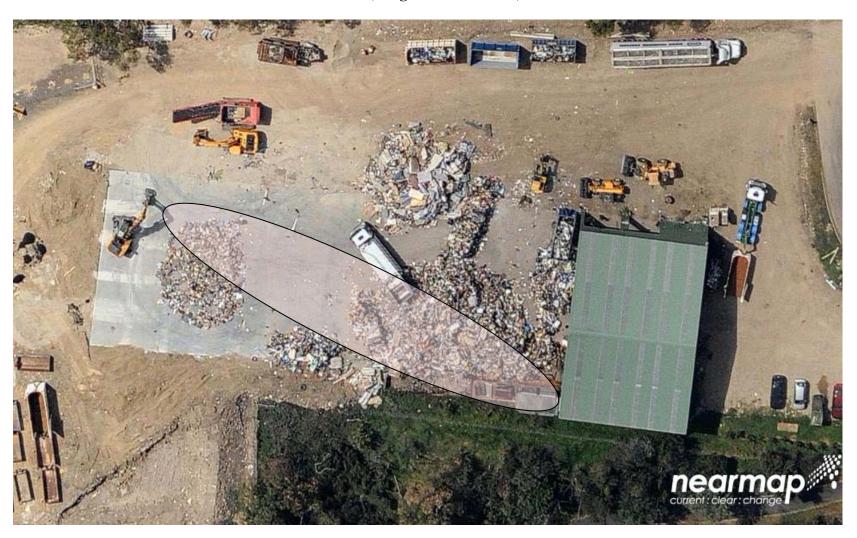
The fire extended through the length of the continuous stack of waste and caused damage to the corner of a large shed and to an attached workshop fashioned out of old shipping containers. The building and workshop damage was considered to be valued at \$50,000.

Ignition was attributed to hot pieces of spring steel dropping from the machines conveyor with the other material. The transfer station manager told me that a powerful magnet designed to extract the metal had been removed from the machine because it regularly caused blockages.

Knox Transfer Station – Area where fire occurred. (image dated 15.02.12)

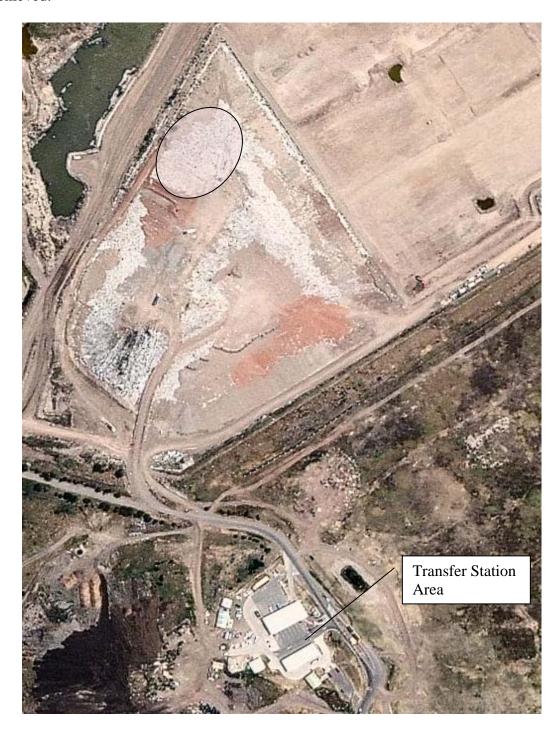
Werribee Landfill – Showing transfer station and current landfill area

The area involved in the fire has been circled. The substantial area of uncovered waste when this image was taken indicates that daily coverage of deposited waste is not always achieved.

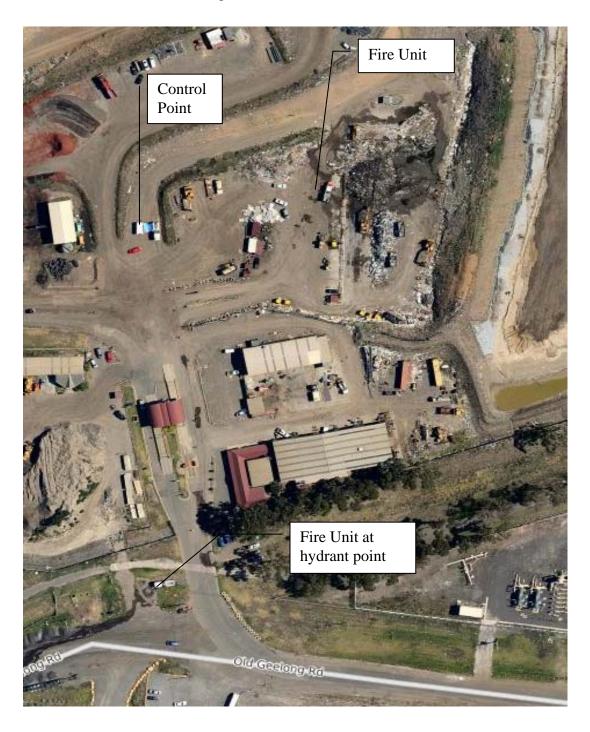
Brooklyn Landfill Fire – (image taken 22.02.2012)

The actual cause is not known but was thought to be the deposit of hot materials earlier in the day that caused smouldering ignition within the heap and flared once it reached the surface of the rubbish pile.

Fire Area can be seen in the image and units are still in attendance.
