FIRE SERVICES  
COMMISSIONER  
VICTORIA

# Operational Review

**Loch Sport Coastal Area Fire  
27 September 2012**

Prepared by IRS Services

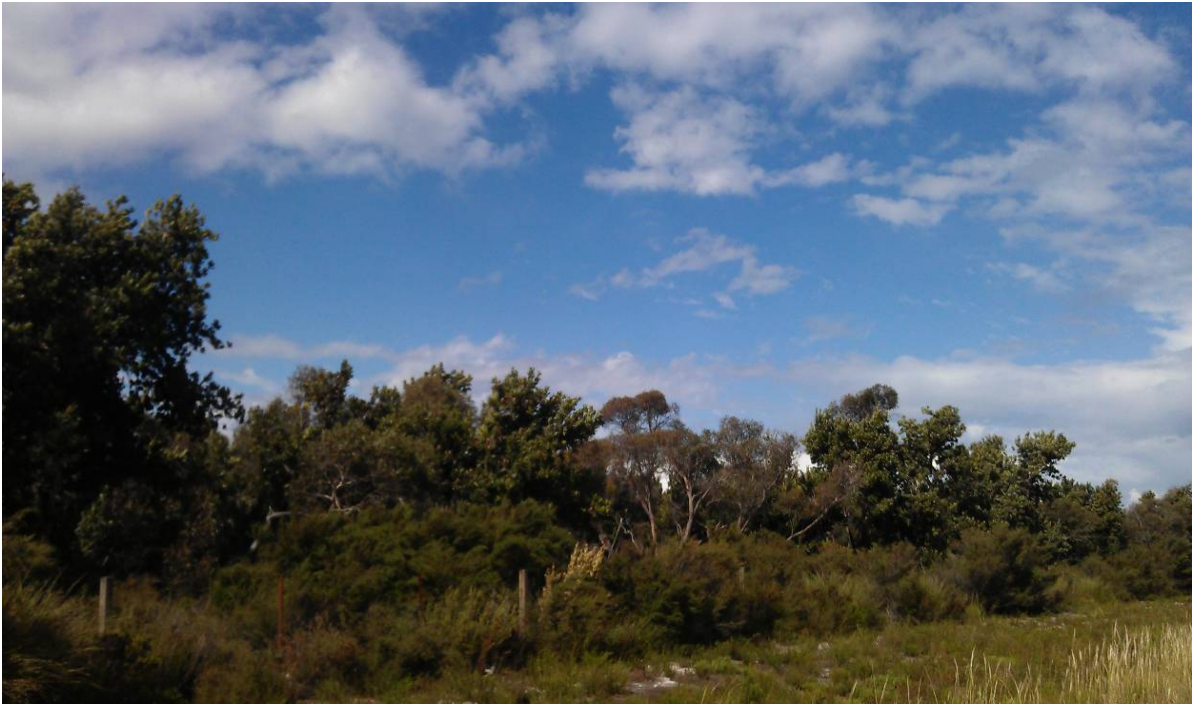
**Image 1 - Typical fuels in non fuel reduced areas**

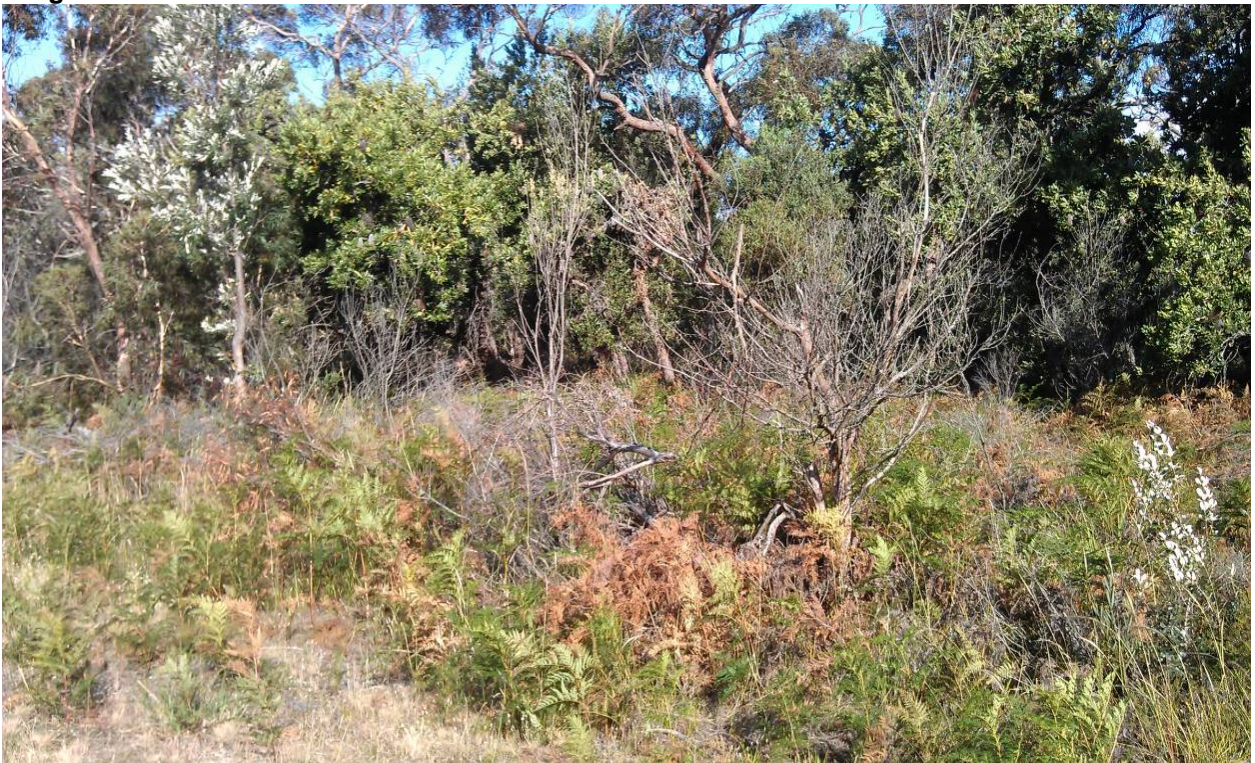
**Image 2 - Fuel on South side of road near fire area**

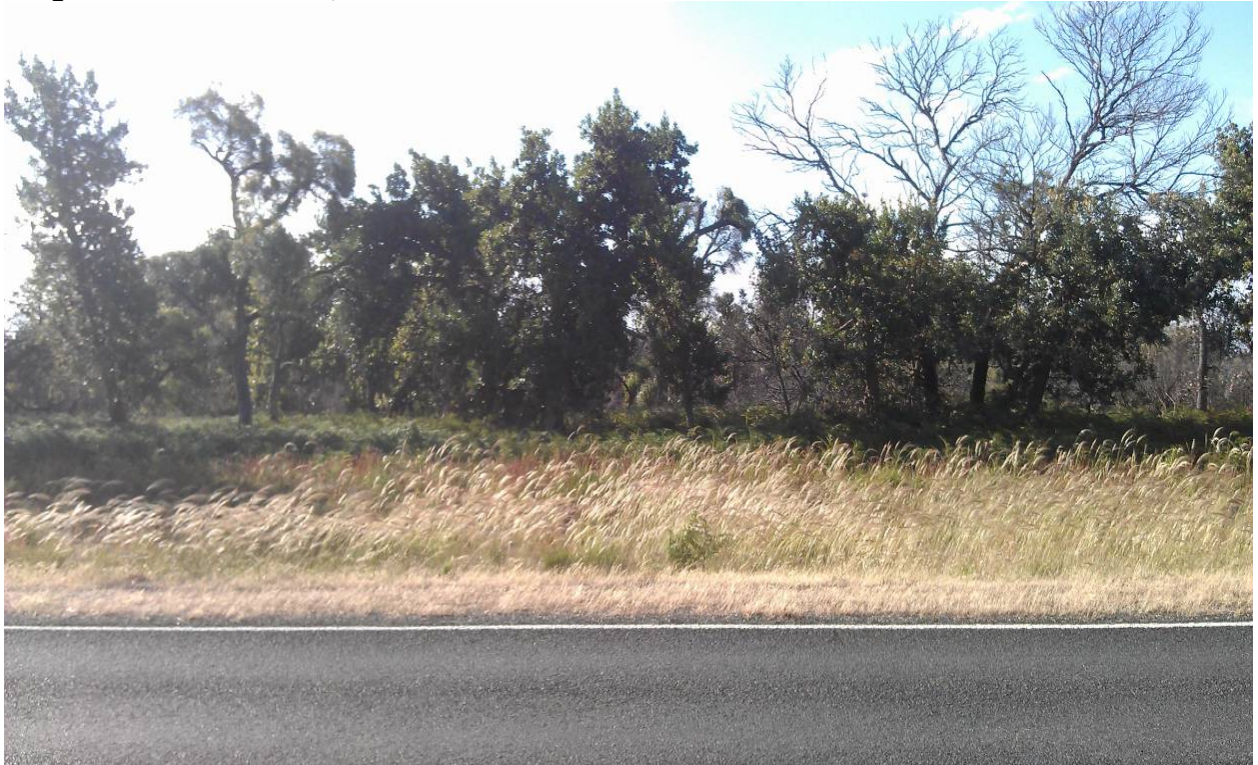
**Image 3 - Nth side of road, FRB conducted in 2009**

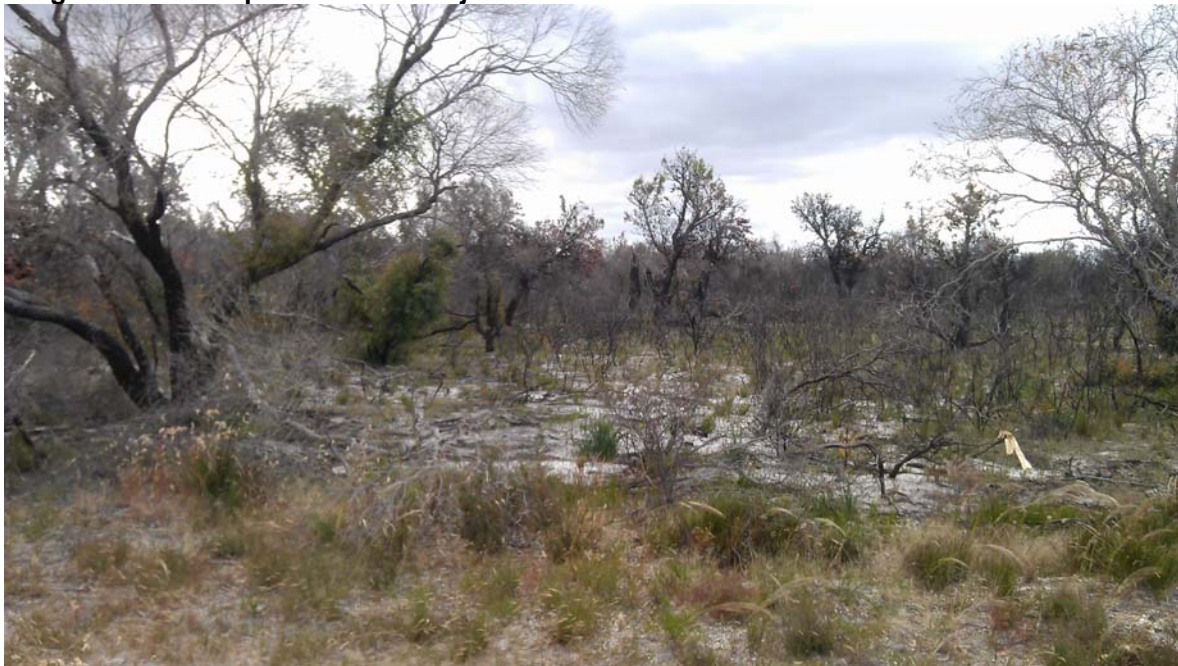
**Image 4 - FRB completed in 2012 adjacent to fire area**
