Emergency
Services
Commissioner

Review of the **TriTech Lubricants factory fire**

19 May 2011

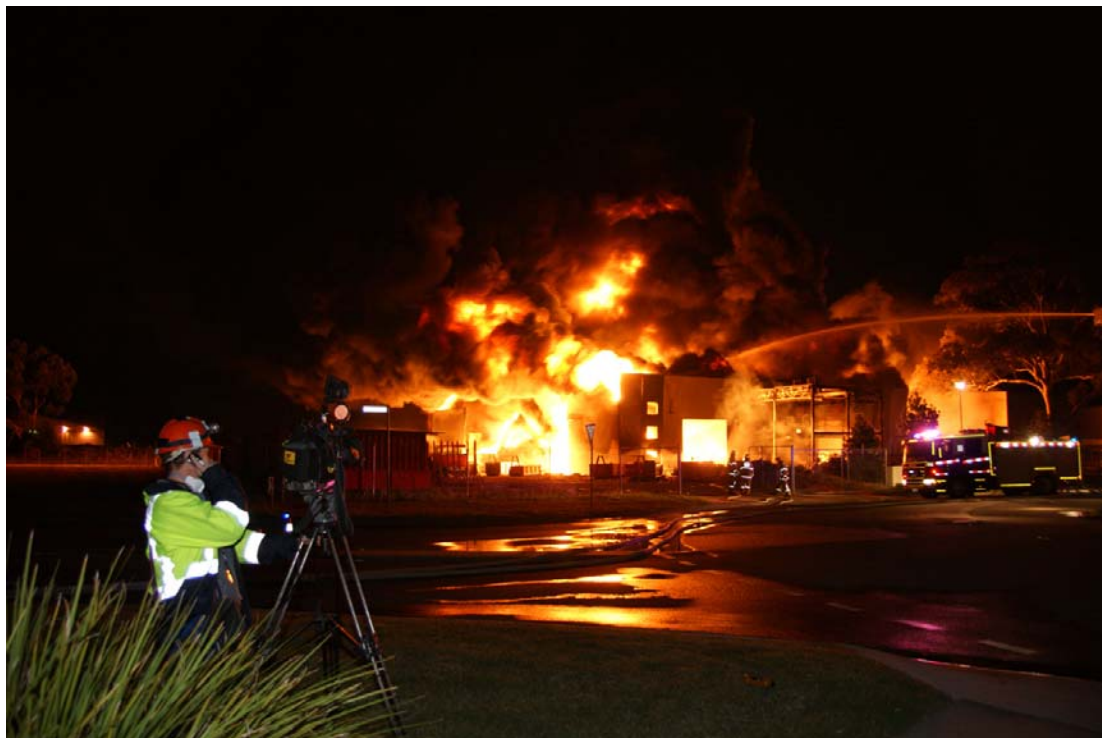
Figure 2. TriTech fire taken at 4.04 am 20 May 2011 (Keith Pakenham, CFA)

The fire spread rapidly through the building and involved plastic containers of product. Uncontained oil spread the fire to the external bulk storage areas. The incident controller requested the dispatch of additional resources, which included a number of fire appliances from the MFB. The rapid development of the fire resulted in a defensive strategy being adopted to protect adjacent buildings and gas pipelines at the rear of the premises. These contained hydrogen (flammable gas), nitrogen (an inert gas) and compressed air.

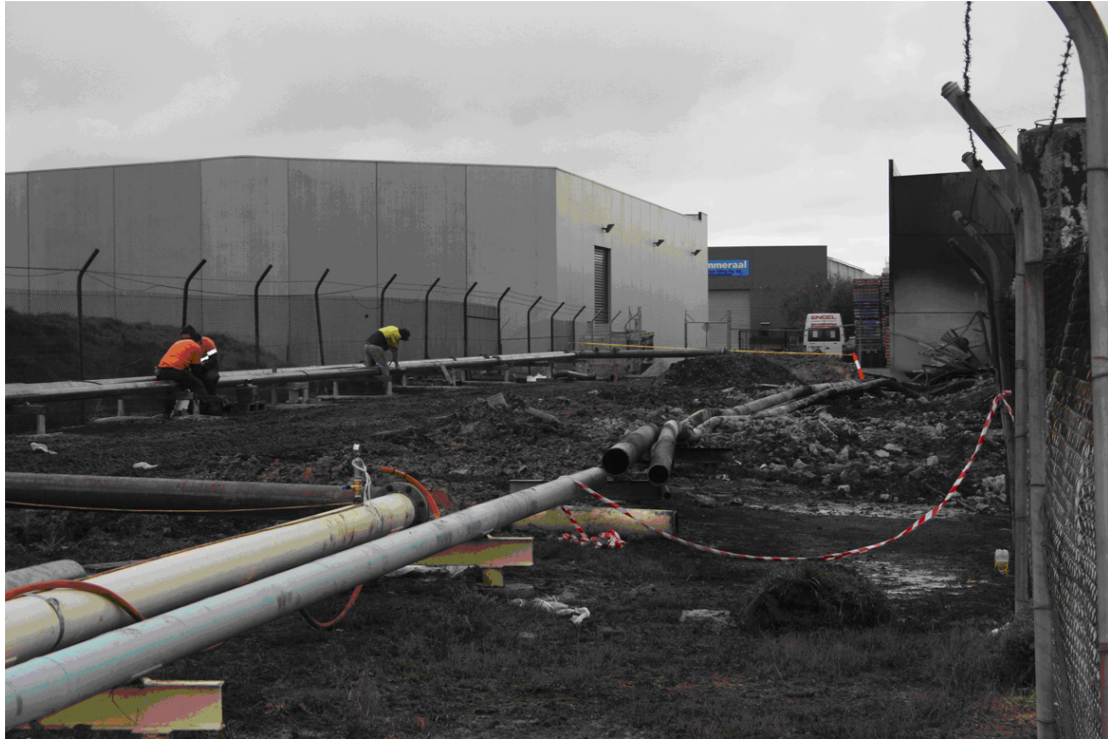
The rear wall of the building collapsed and damaged the nitrogen pipe line, however this did not present a hazard. The gas supplies were later isolated by a BOC representative. Water supplied by hydrants near the factory was insufficient so water was pumped from Greens Road, approximately one kilometre away, by means of a pump relay⁴. Further water was drawn from storage at the neighbouring Viridian glass factory. A large volume of water was used during fire fighting operations to cool the fire sufficiently to enable the application of fire fighting foam, which ultimately extinguished the fire.

Figure 3. Hydrogen, nitrogen and compressed air pipelines located to the rear of TriTech (K Pakenham, CFA)

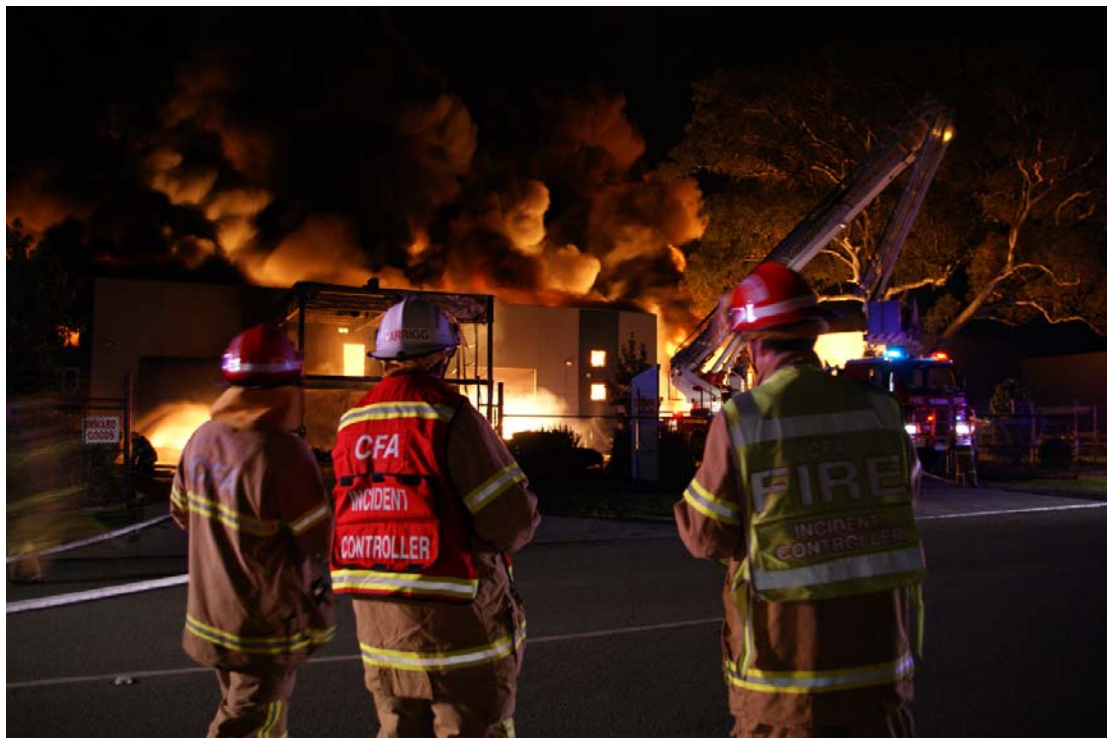
The review team noted that the tabards worn on the fireground to identify the 'incident controller' did not comply with AIIMS and the EMMV. These specify that a white tabard is to be worn. Incident controller tabards worn on the fireground at TriTech were red and lime green. The lime green tabards currently used by CFA are reported to lack visibility when worn with the light-coloured Nomex protective clothing.

Figure 6. Incident controller tabards (note: photograph taken during the handover of incident control 8.55 pm) (Keith Pakenham, CFA)

The colours of incident management tabards worn on the fireground were inconsistent with both AIIMS and the EMMV.

The Fire Services Commissioner ensures that there is a single standard for the tabards worn by the IMT on the fireground and in control centres to ensure consistency and aid interoperability.

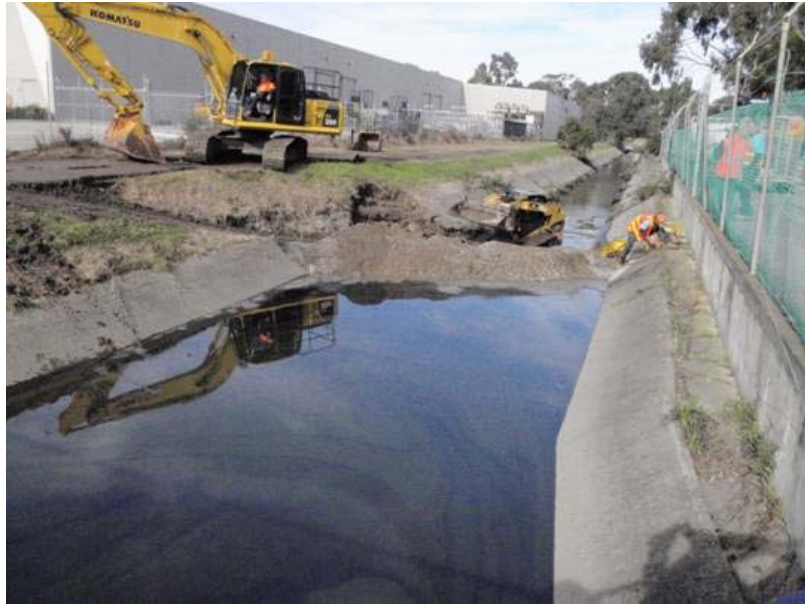
The EPA estimated that this was one of the largest oil spills to have entered Melbourne's drainage system and presented Melbourne Water with a significant and costly recovery. Melbourne Water overcame many challenges to remove product and contaminated water and dispose of the contamination. It involved good collaboration between a number of waste management transport, storage and logistics service providers.

Figure 7. Sand bunding used to contain oil and contaminated water run-off (Source: Melbourne Water)
