Emergency
Services
Commissioner

Review of the **TriTech Lubricants factory fire**

19 May 2011

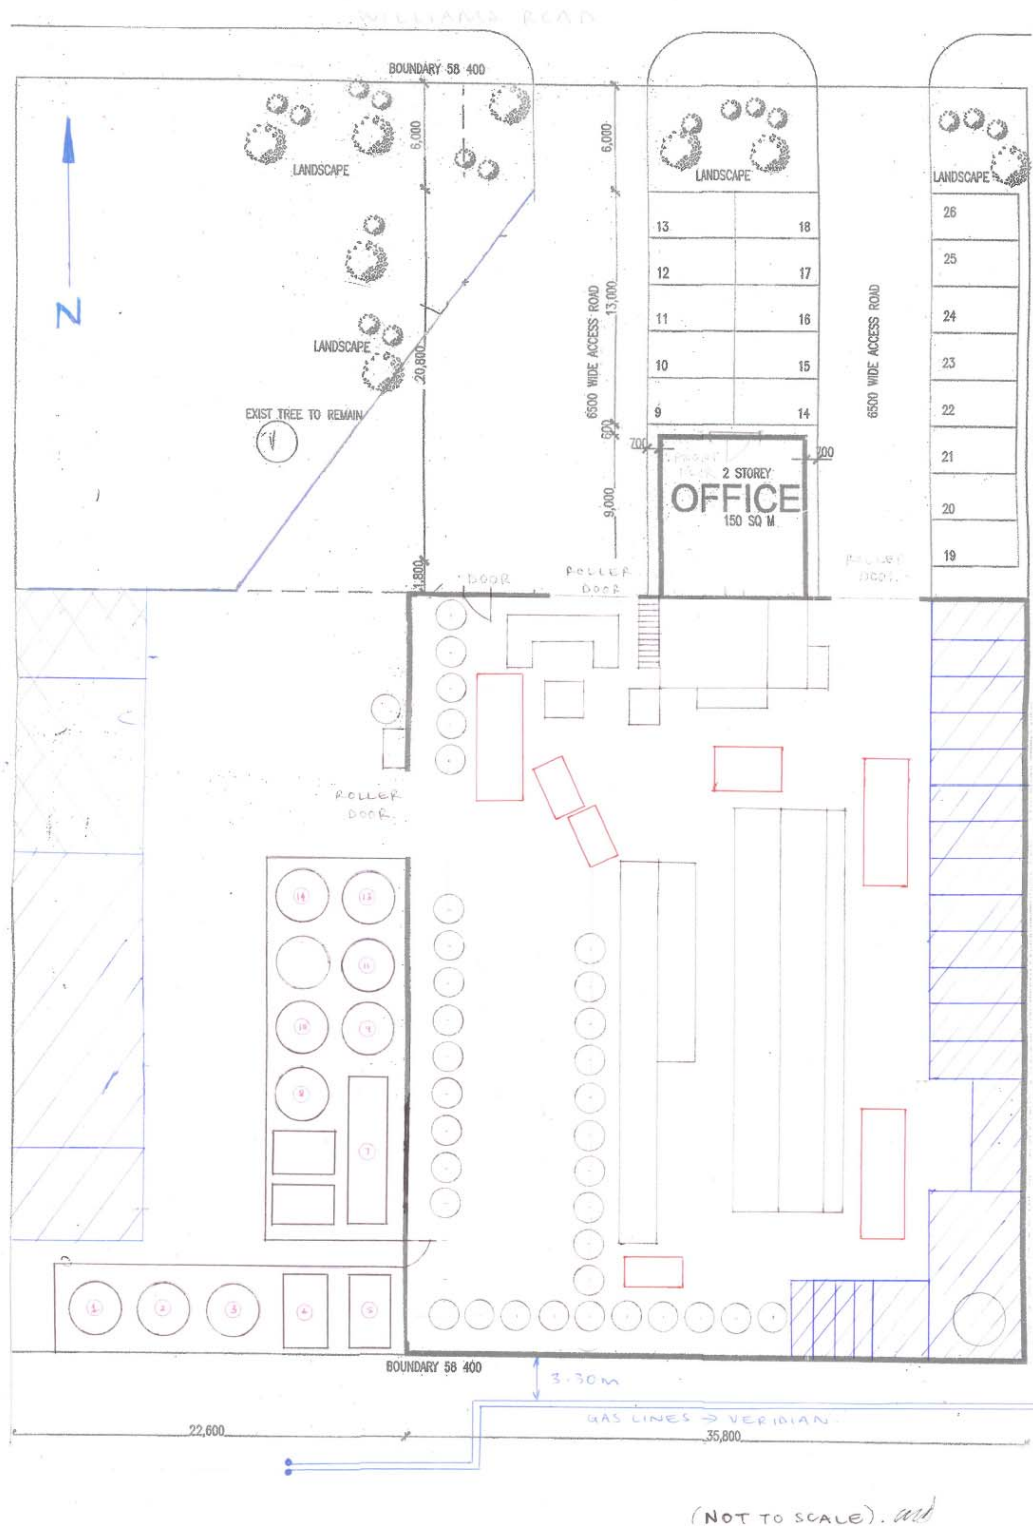
The building was approximately 1,685 square metres (m²) in size. It incorporated a two-level office at the front with a floor area of 150 m² and a warehouse at the rear with a floor area of 1,535 m² (see Figure 1). The building construction comprised horizontal concrete tilt slabs supported by a heavy steel portal frame with a tin clip-lock roof. The building had fire hose reels installed, but not an on-site fire hydrant or fire detection system.

Figure 1. Site and building layout (Source: CFA)

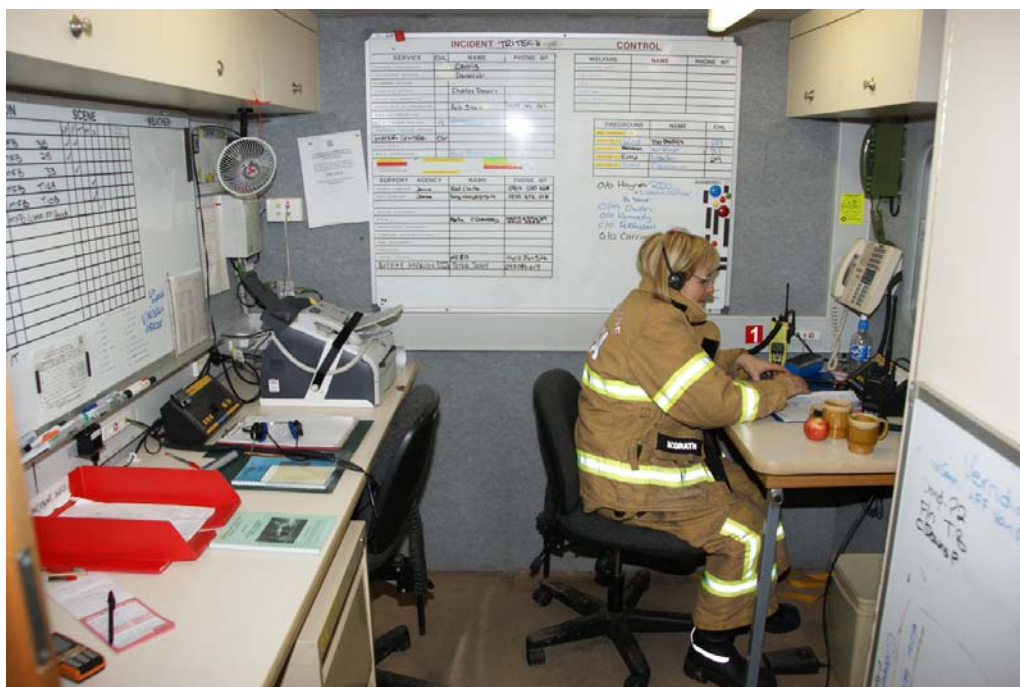
The mobile communications vehicle (MCV) from Patterson River CFA brigade arrived at 9.10 pm and provided on-scene communications. The review team were told that the vehicle was too small to accommodate IMTs and EMTs at complex, large or prolonged incidents.

Figure 5 Mobile communications vehicle (Keith Pakenham, CFA)

The MFB has a well-equipped, state-of-the-art command and control vehicle that provides spacious meeting areas for management teams, including information and media personnel. The review team believes the MFB vehicle should be available for large incidents in fringe areas of CFA jurisdiction.
